Technical Consultation on Corrosion in
Fertilizer Plants

COUNTRY PAPER FROM KUWAIT

CORROSION PROBLEMS EXPERIENCED IN AMMONIA AND UREA PLANTS*

Case of surface condensers of the ammonia compressors

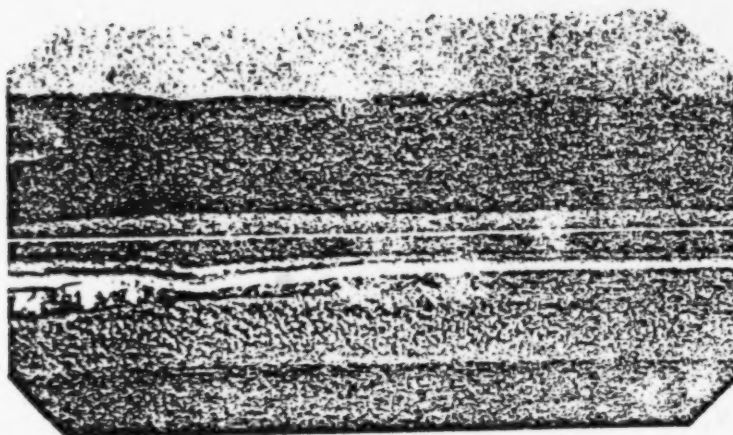
3.1. The Aluminium Brass tubes are considered not suitable a material in our condensers from design and actual operation point of view. As the sea water velocity is excessive enough to cause impingment attack to the tubes material from inside.

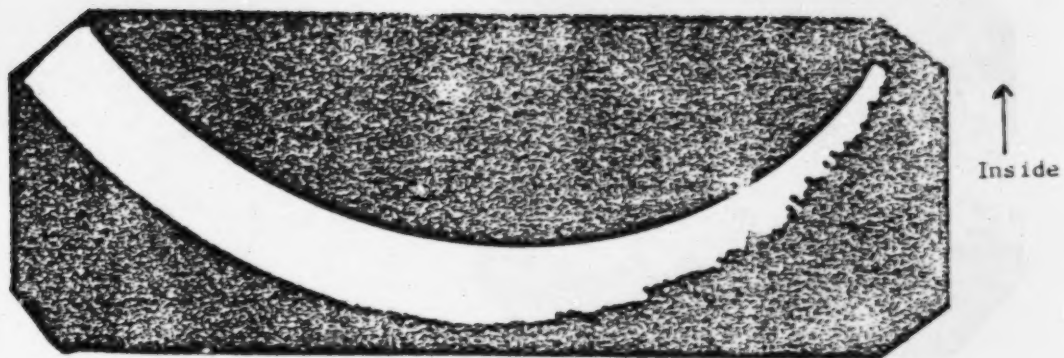
Photo 2 View of internal surface.

The whole area was covered with brownish black scale. After descaling leakage was found to take place longitudinally and no significant corrosion was observed in other areas. See Photo (2).

- 4.1. Modifying tubes material of the surface condensers. Both Cu/Ni 70/30 and Titanium were put under investigation as alternative materials.
- 4.2. It was recommended to replace the existing channels with rubber lining instead of Epoxy coating.
- 4.3. Screens at sea water pumps section should be of more narrow wire meshes to prevent large solids and marine growth to escape and plugging the tubes.
- 4.4. Proper sea water chlorination to prevent plugging of tubes by large marine growth.

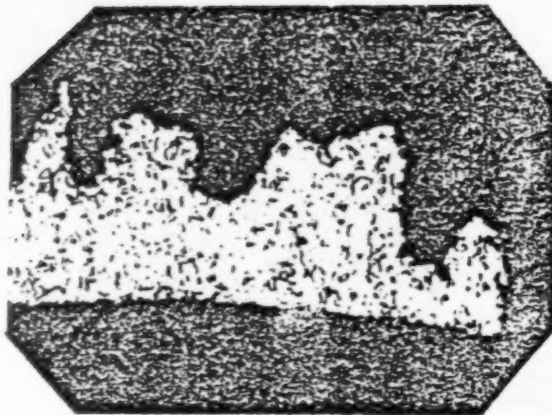
The view of cross section and microscopic observation of longitudinal and circumferential cross section at the leaked and corroded part are shown in Photo 3 & 4. The leakage is caused evidently by the corrosion of outside. However inside of tube, very slight corrosion is recognized as shown Photo (4-d).

Photo 3 A: Leaked part circumferential.

Photo 3 B: Corroded part longitudinal.

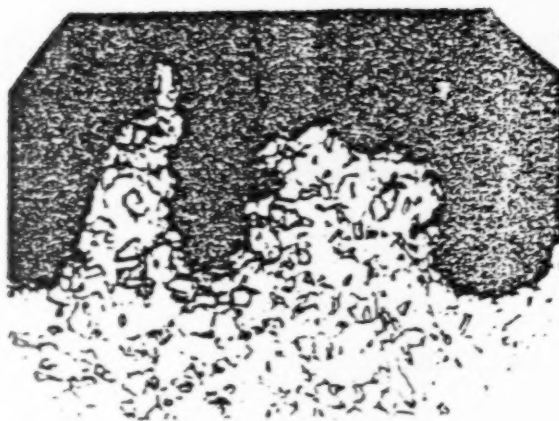
Photo 4 A: End point of leaked part shown in Photo 18 A.

Photo 4 B: Corroded part shown in 18 B.

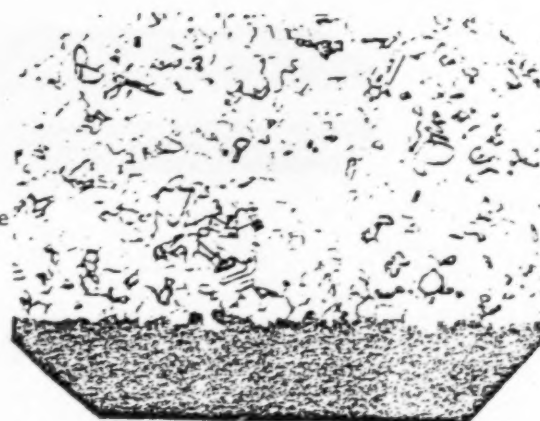
Photo 4 C: Corroded part shown in photo 18 B.

Photo 4 D: Slight corroded part of inside.

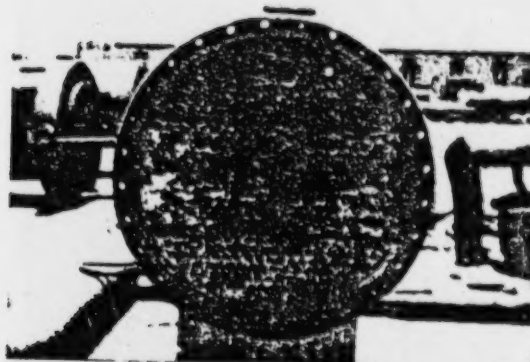
Photo 1)

2.1.1. Tube sheets were found covered by heavy salt deposits of white and blue colour. These salt deposits were heavier on west side tube sheet than that of the eastern one. (See Photos 1 & 2), after cleaning of tube sheets it was noted that a corroded groove around the tube end (1 - 6 mm. depth) and some of these tubes end were found completely eaten out - See Photoc 3, 4. The surrounding areas on the tube sheets were subjected to corrosion of 5 m.m. maximum depth. Generally it was clear that corrosion is more severe in the west tube sheet than in the east one - See Photos No. 5, 6.

West Tube sheet Before cleaning.

Heavy corrosion products and sea water salts.

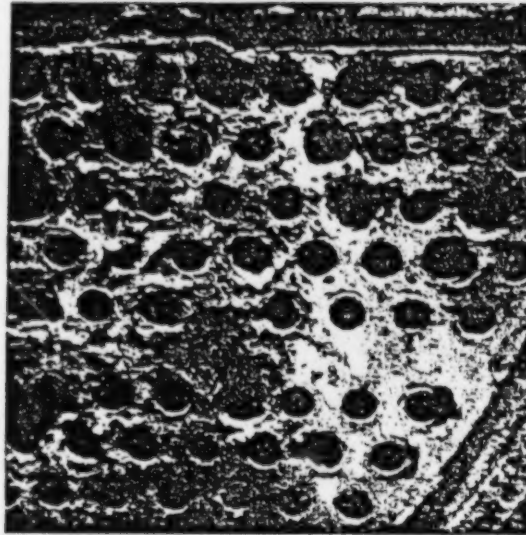
photo 2)

East Tube sheet before cleaning.

Notice the difference between the amount of salt deposits on East and West tube sheets.

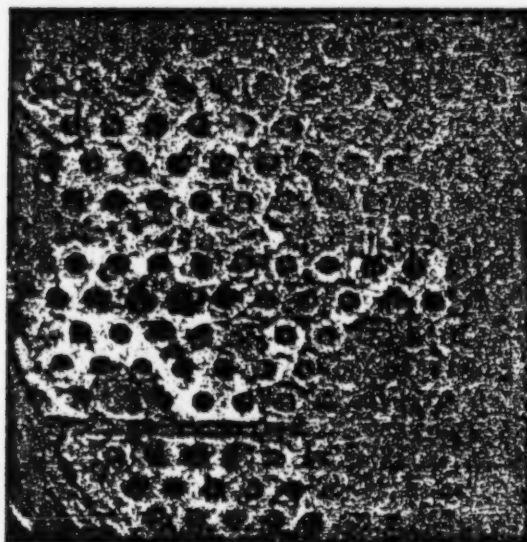
photo (3)

West Tube Sheet after cleaning.

Notice the corroded grooves around the tube ends, and the tube end which completely eaten out.

- 4.3. All tubes ends were over expanded with special care to leaking ones which were plugged. The corroded grooves on tube sheet and corroded tubes ends to be filled by welding using Monel 67 filler wires and gas welding.

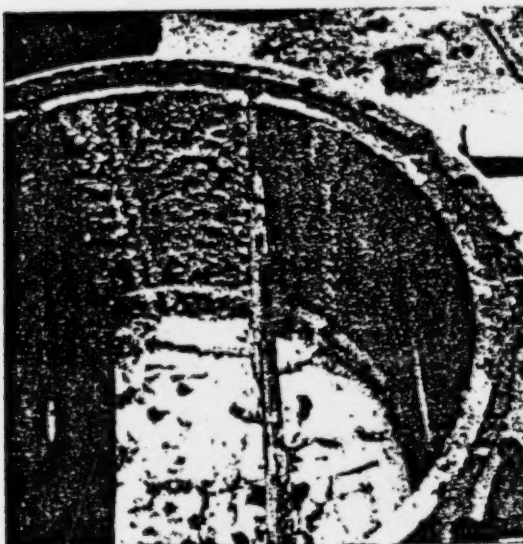
photo 7)

Partition plates edges were found severely corroded at their contact with the tube sheet as illustrated in Photo No. 7. A luster film of crystalline deposits green in colour were found adherent to the internal surface of bonnet between its two partition plates i.e. in the 2nd and 3rd flow passes as illustrated in Photo No. 8.

2.1.4. The three Magnesium anodes fixed on the partition plates of the east Bonnet were found completely missed and the supporting bolts were corroded out. One of the bolts was found completely missed leaving a hole at its position. (See Photo No. 7).

The potential difference exists between the partition plates made of carbon steel and the tube sheets of Cu/Ni on contact with each other after peeling off of coating and anodes consumption produced electron flow between them.

Thus corrosion start and continued on the less corrosion resistant metal (Carbon steel of the partition plate - anodic) caused it to be eaten out.

East Bonnet

Galvanic corrosion on the partition plates edges at their contact with the tube sheet after peeling of coating. Notice the hole at position of the supporting bolts of Magnesium anode.

- 4.1. Magnesium anodes should be replaced by Zinc alloy anodes "C-sentry" which are the suitable and efficient anodes for cathodic protection in sea water medium. Bakelite or rubber washers should be fixed under the bolt heads and nuts to avoid galvanic corrosion of partition plates. However study and evaluation in hand to use Aluminium anodes which is better than Magnesium anodes in sea water service.

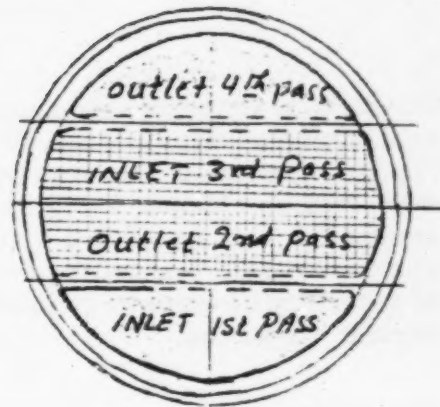
The sea water containing leaked ammonia attacked the Cu/Ni layer on the tube sheets at both condenser ends. This attack is remarkably increased in the order from the 1st to the 4th passes with the exception of the main sea water inlet and outlet at the east side. This is due to that at the inlet the sea water is free from ammonia while at the main outlet the ammonia contaminant in sea water has been consumed in the corrosion reactions with copper and precipitation of sea water salts. (See Fig. 4).

WEST TUBE SHEET

EAST TUBE SHEET

-  No to very low: Signs of Corrosion and Salts deposition.
-  Medium: Corrosion and Salt deposition
-  High Corrosion area and Heavy Salts deposition.

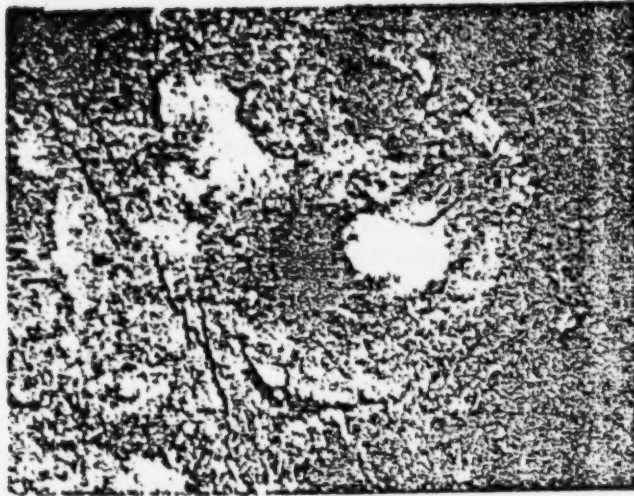
5.2. Intercrystalline (Intergranular corrosion).

This type of cracking can be occurred when stainless steel contains more than 0.03% C. and not stabilized by Niobium or Titanium and that it has undergone thermal processing (Welding or heat treatment) in the so called sensitization range (500°C - 800°C).
